Confirmation of Diagnosis

Excess of clearance between piston and liner

Summary- This document consists of the failure detection and verification report of a cylinder in a Waukesha P9390 GSI engine with 4000 hours of operation. Windrock engine monitoring was performed, the results were analyzed, detecting an impact at the beginning of the descending effect. The engine was disassembled in order to verify the damage diagnosed, after being repaired, the analysis was repeated to verify the disappearance of the impact.

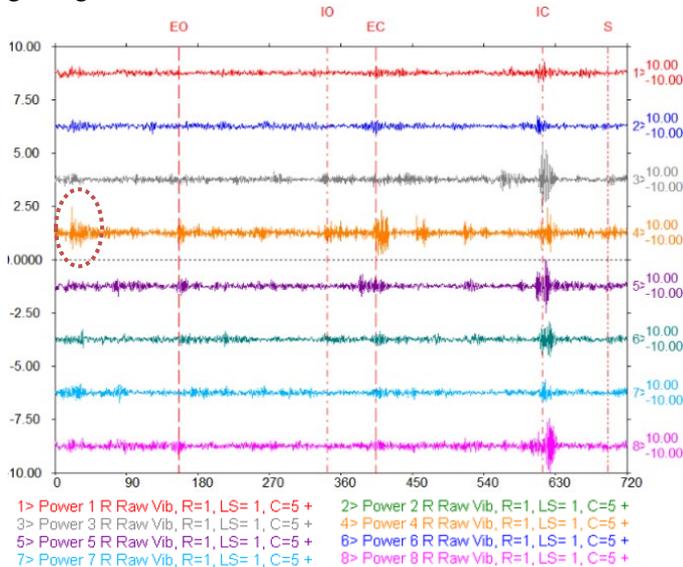
Cil 4R It is observed an impact in the beginning of the descending effect after the spark, it could be a symptom of gaps in the piston set, suggesting the check of the same ones.

Graph 1: Vibrations Raw (unfiltered) in drive heads R, cylinder 4 (yellow), sensor in vertical direction respect to piston displacement direction.

As the analysis of crank-angle-referenced 4R cylinder signals exhibits abnormalities in the combustion stroke after the top dead center, the parameters of combustion, carburation and ignition advance are verified without observing any abnormalities, it being ruled out that the fault were coming from detonation, in consequence it is supposed that the problem is coming from excessive piston/liner diameters clearances.

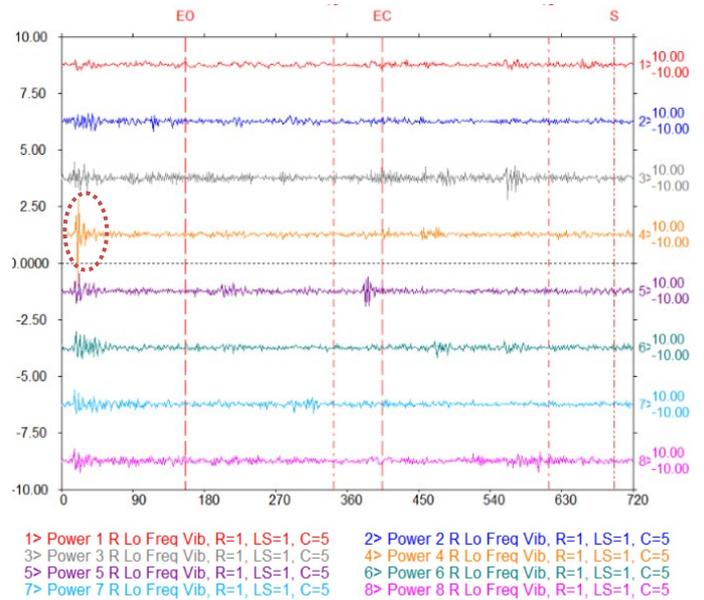
Graph 2: Vibrations Low Freq in cylinder banks R, cylinder 4 (yellow), sensor in horizontal direction respect to the movement of the piston.

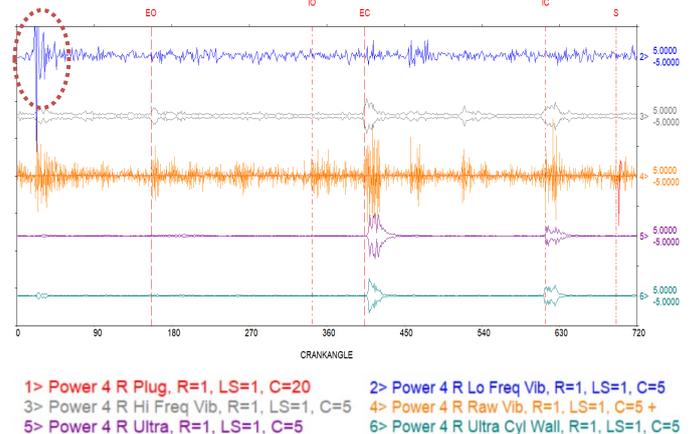
Graph 3: Side impact on 4R cylinder, low frequency vibration (blue).

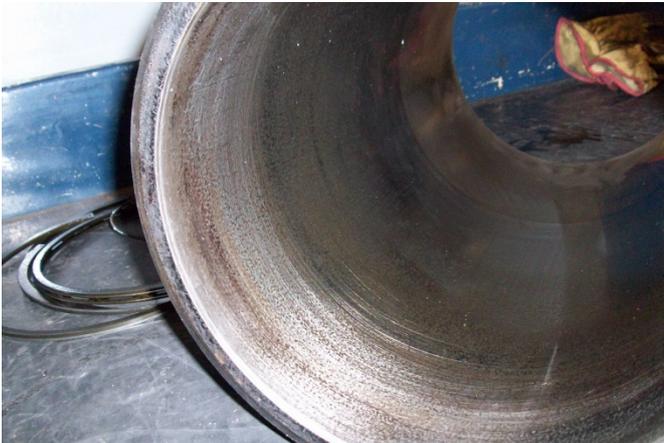
There is also widespread wear on all pistons/liners set, resulting from an overload in the use of the engine (since it was charged from the start of its operation above 103% of its rated power).

The assembly was disassembled with the following findings: The liner shows a wear pattern of abrasive character and the cylinder head and piston cap with blows signs.

Picture 1: Liner internal piston and rings path.

It may be noted that the cylinder liner suffered damage throughout the stroke of the piston, indicating that at some point a foreign body was present in the combustion chamber.

Piston, liner and rings were changed and the condition analysis of machinery was carried out again to verify the reduction of the impact signal after the repair.

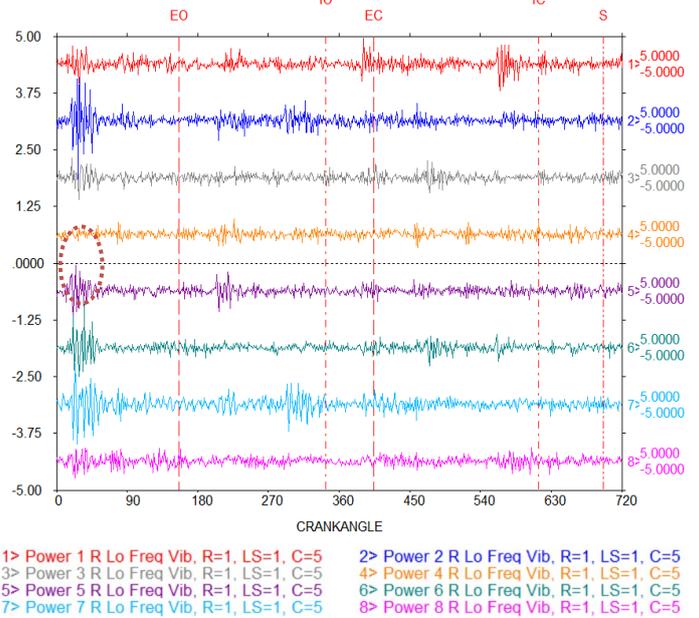
Graph 4: Vibrations Low Freq in cylinder banks drive R

A comparative and significant improvement is presented in the Cil # 4R, after the change of liner and rings.

In addition, abnormal vibrations in the rest of the cylinders are remaining advertising the need of their maintenance/inspection and, from now, limiting the use of the engine to the maximum allowed power supplied by the manufacturer.
